APPENDIX A
Rural Road Safety Audit Photographs

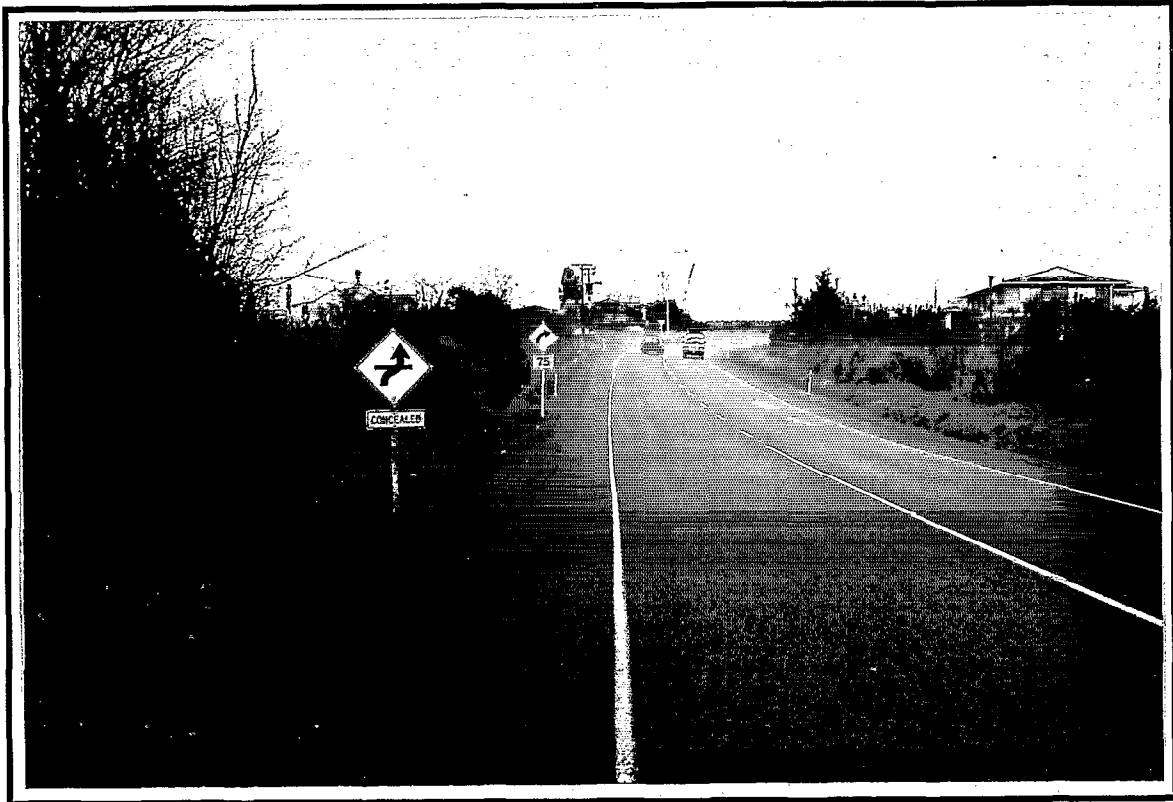
Photograph A1 Mixture of warning signs provides confusing message to approaching motorists.

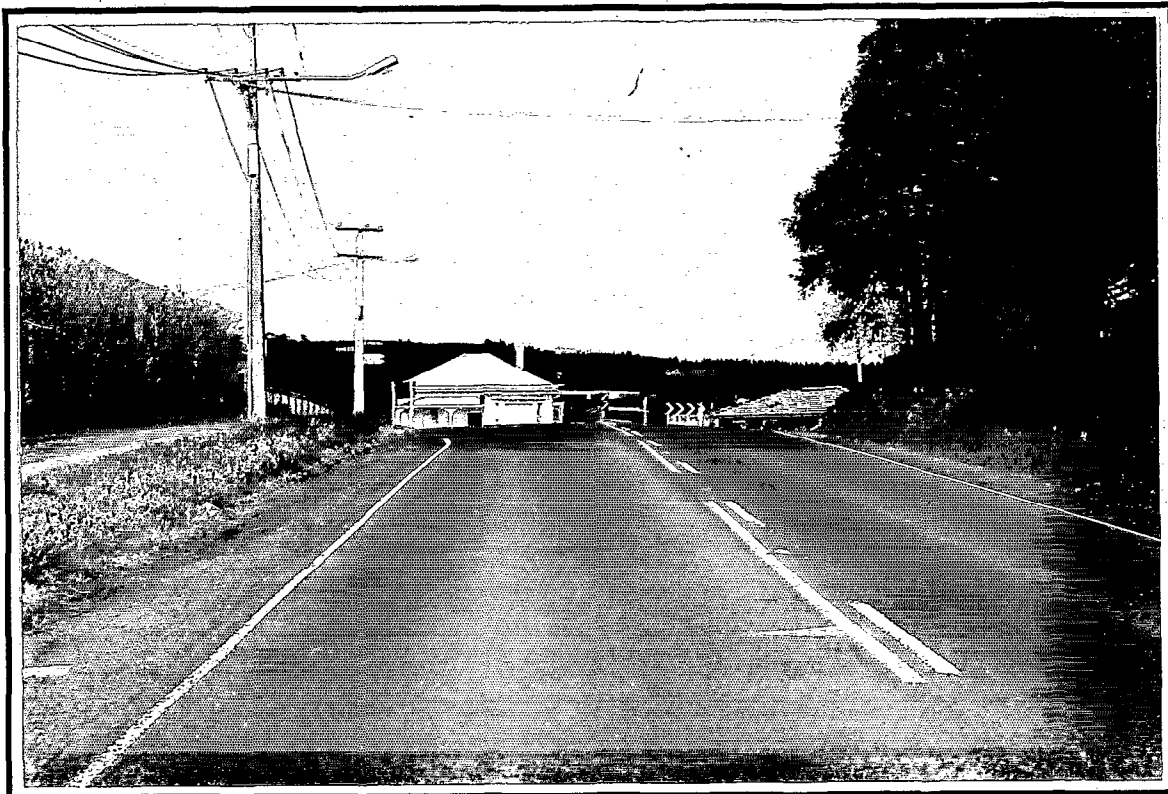
Photograph A2 Poorly located chevron sight board. Should be mounted in line with the centre of approaching traffic lane.

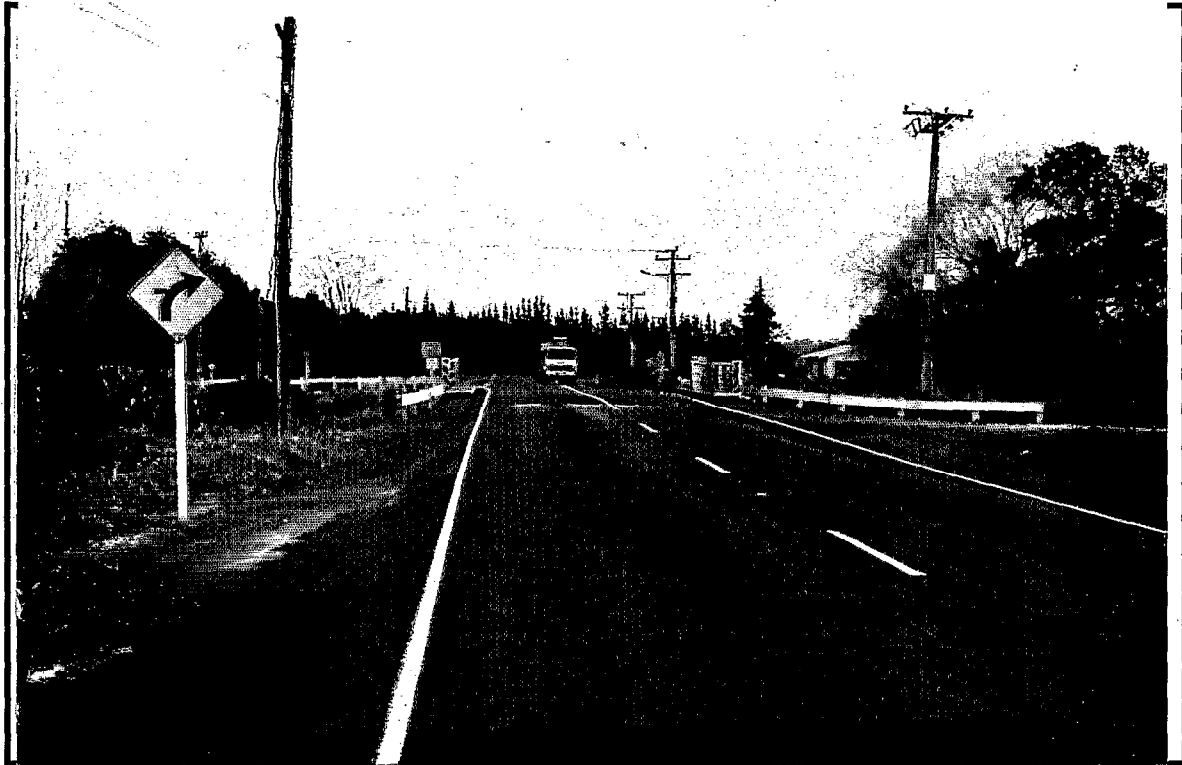
Photograph A3 Poorly located bridge end marker posts which do not define the narrowest part of the bridge deck width.

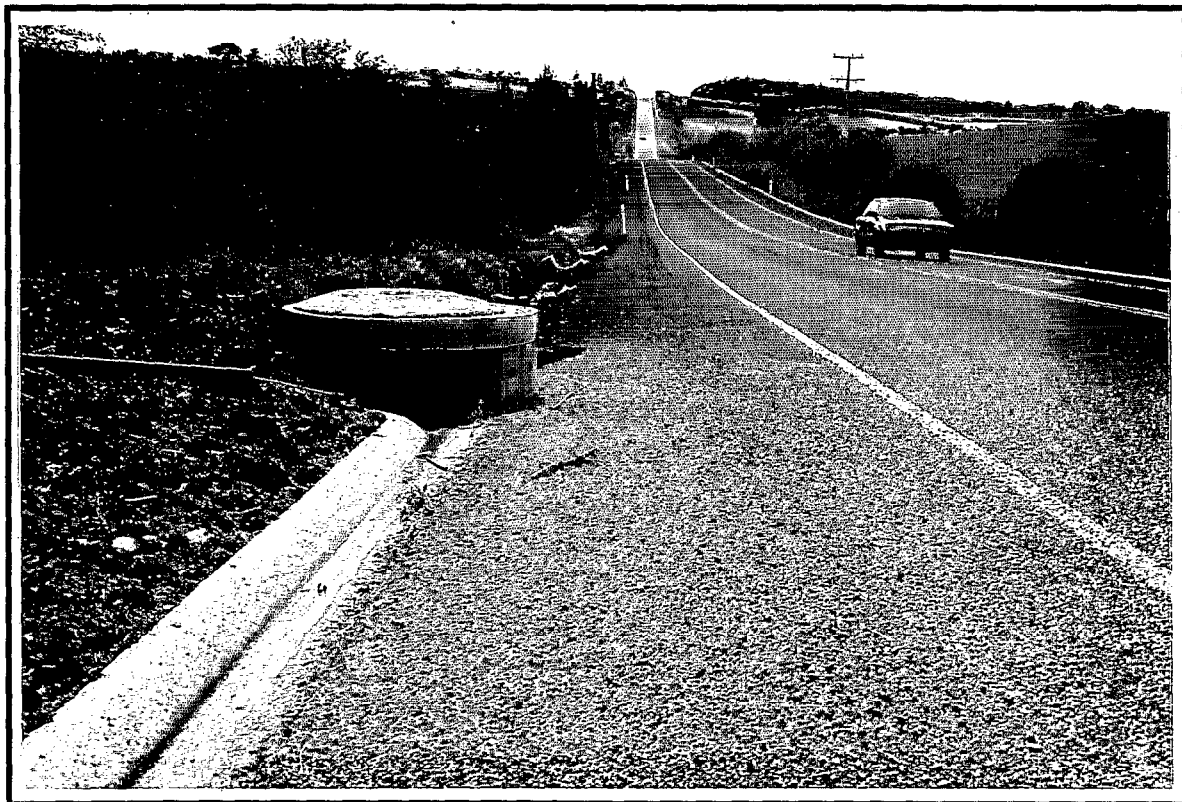
Photograph A4 Raised concrete sump creating an unnecessary roadside safety hazard to errant vehicles.

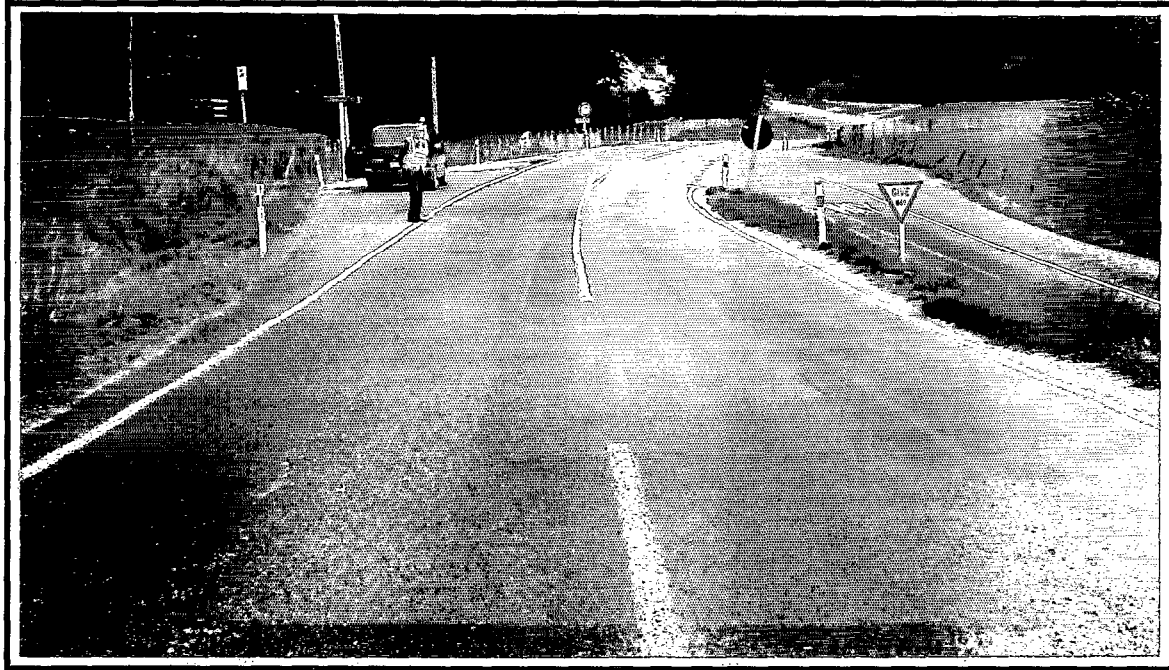
Photograph A5 Poor intersection layout due to low angle of entry. Note how the Give Way sign located on the side road is visible from the main road.

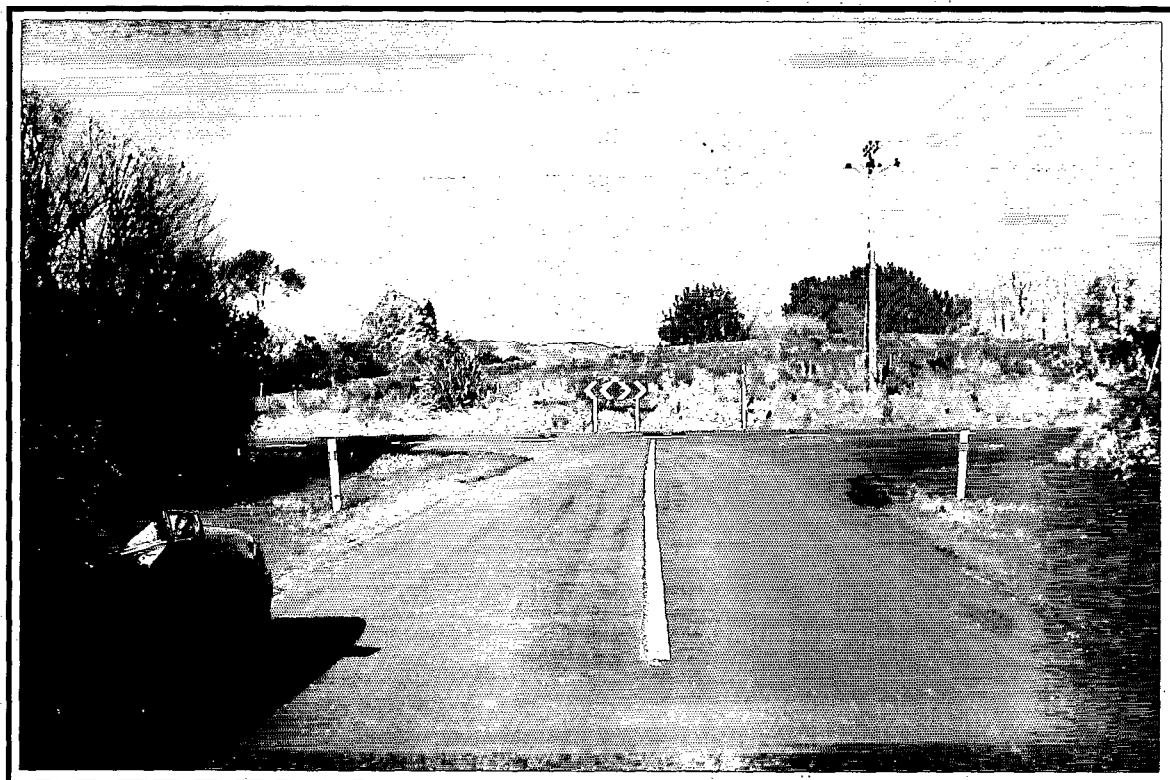
Photograph A6 Good use of a chevron sight board to improve the conspicuity of an intersection to approaching traffic.
